NRL Memorandum Report 5697

Projectile Impact Effects on Aircraft Wire Harnesses

January 8, 1986

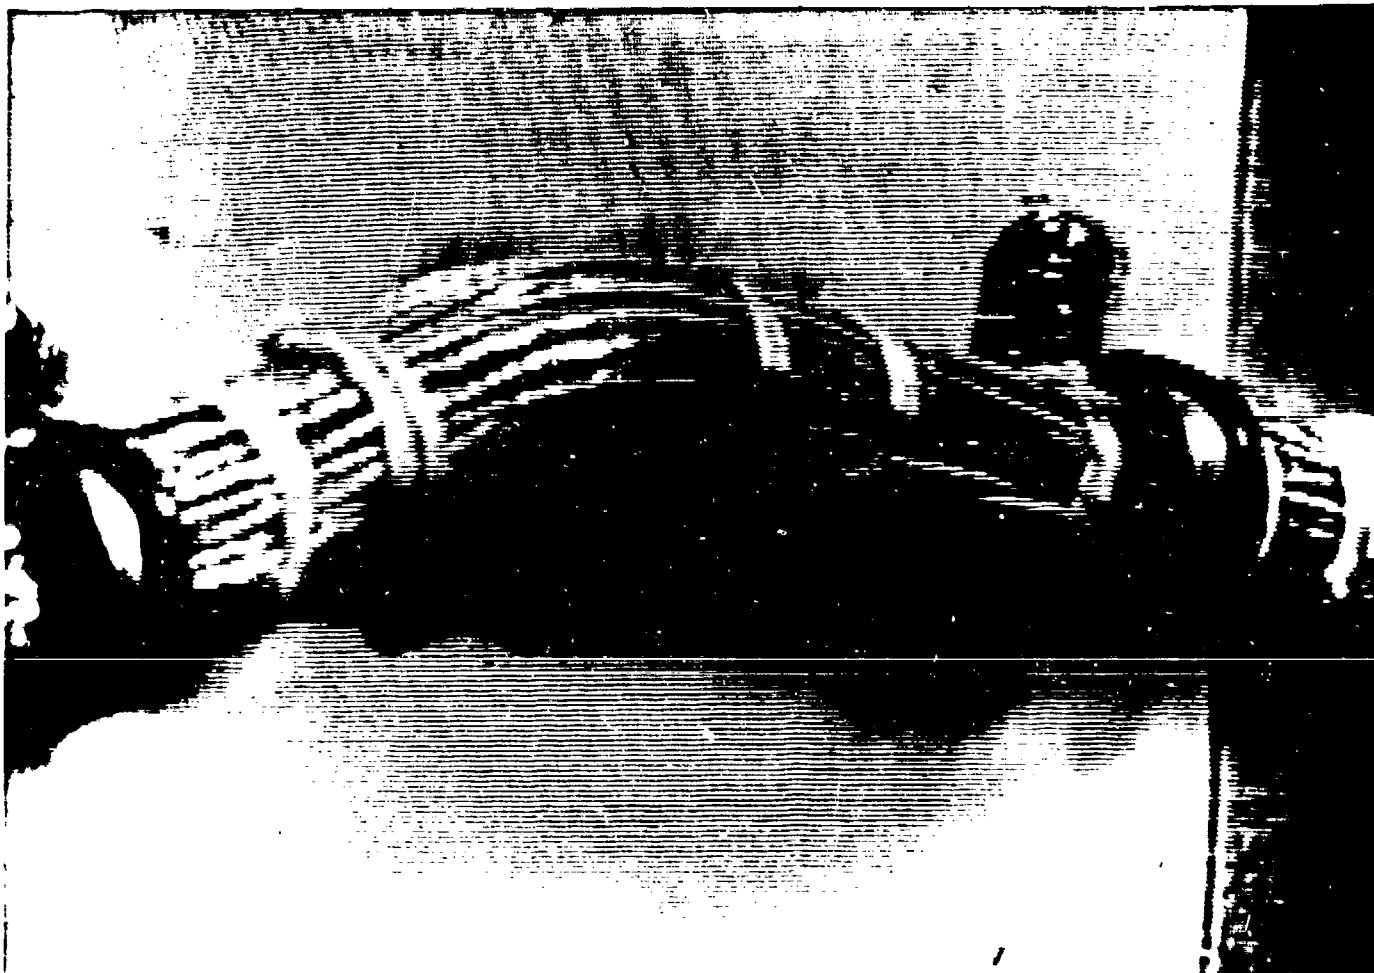
The first shot was conducted with the .30-caliber ball, fired at the MLL-W-81381/11 type harness. The projectile severed wires in the lower part of the harness, and deformed the remaining wires of the bundle. The close-up view in Figure 7 shows the deflection produced by the impact, the carbon deposited on the painted surface, and the hole in the plate where the projectile passed through. A short circuit during the penetration caused arcing that tripped one ac breaker.

Fig. 7 — The initial damage to the MH-W-81381/11 harness from the impact of a .30-caliber bullet.

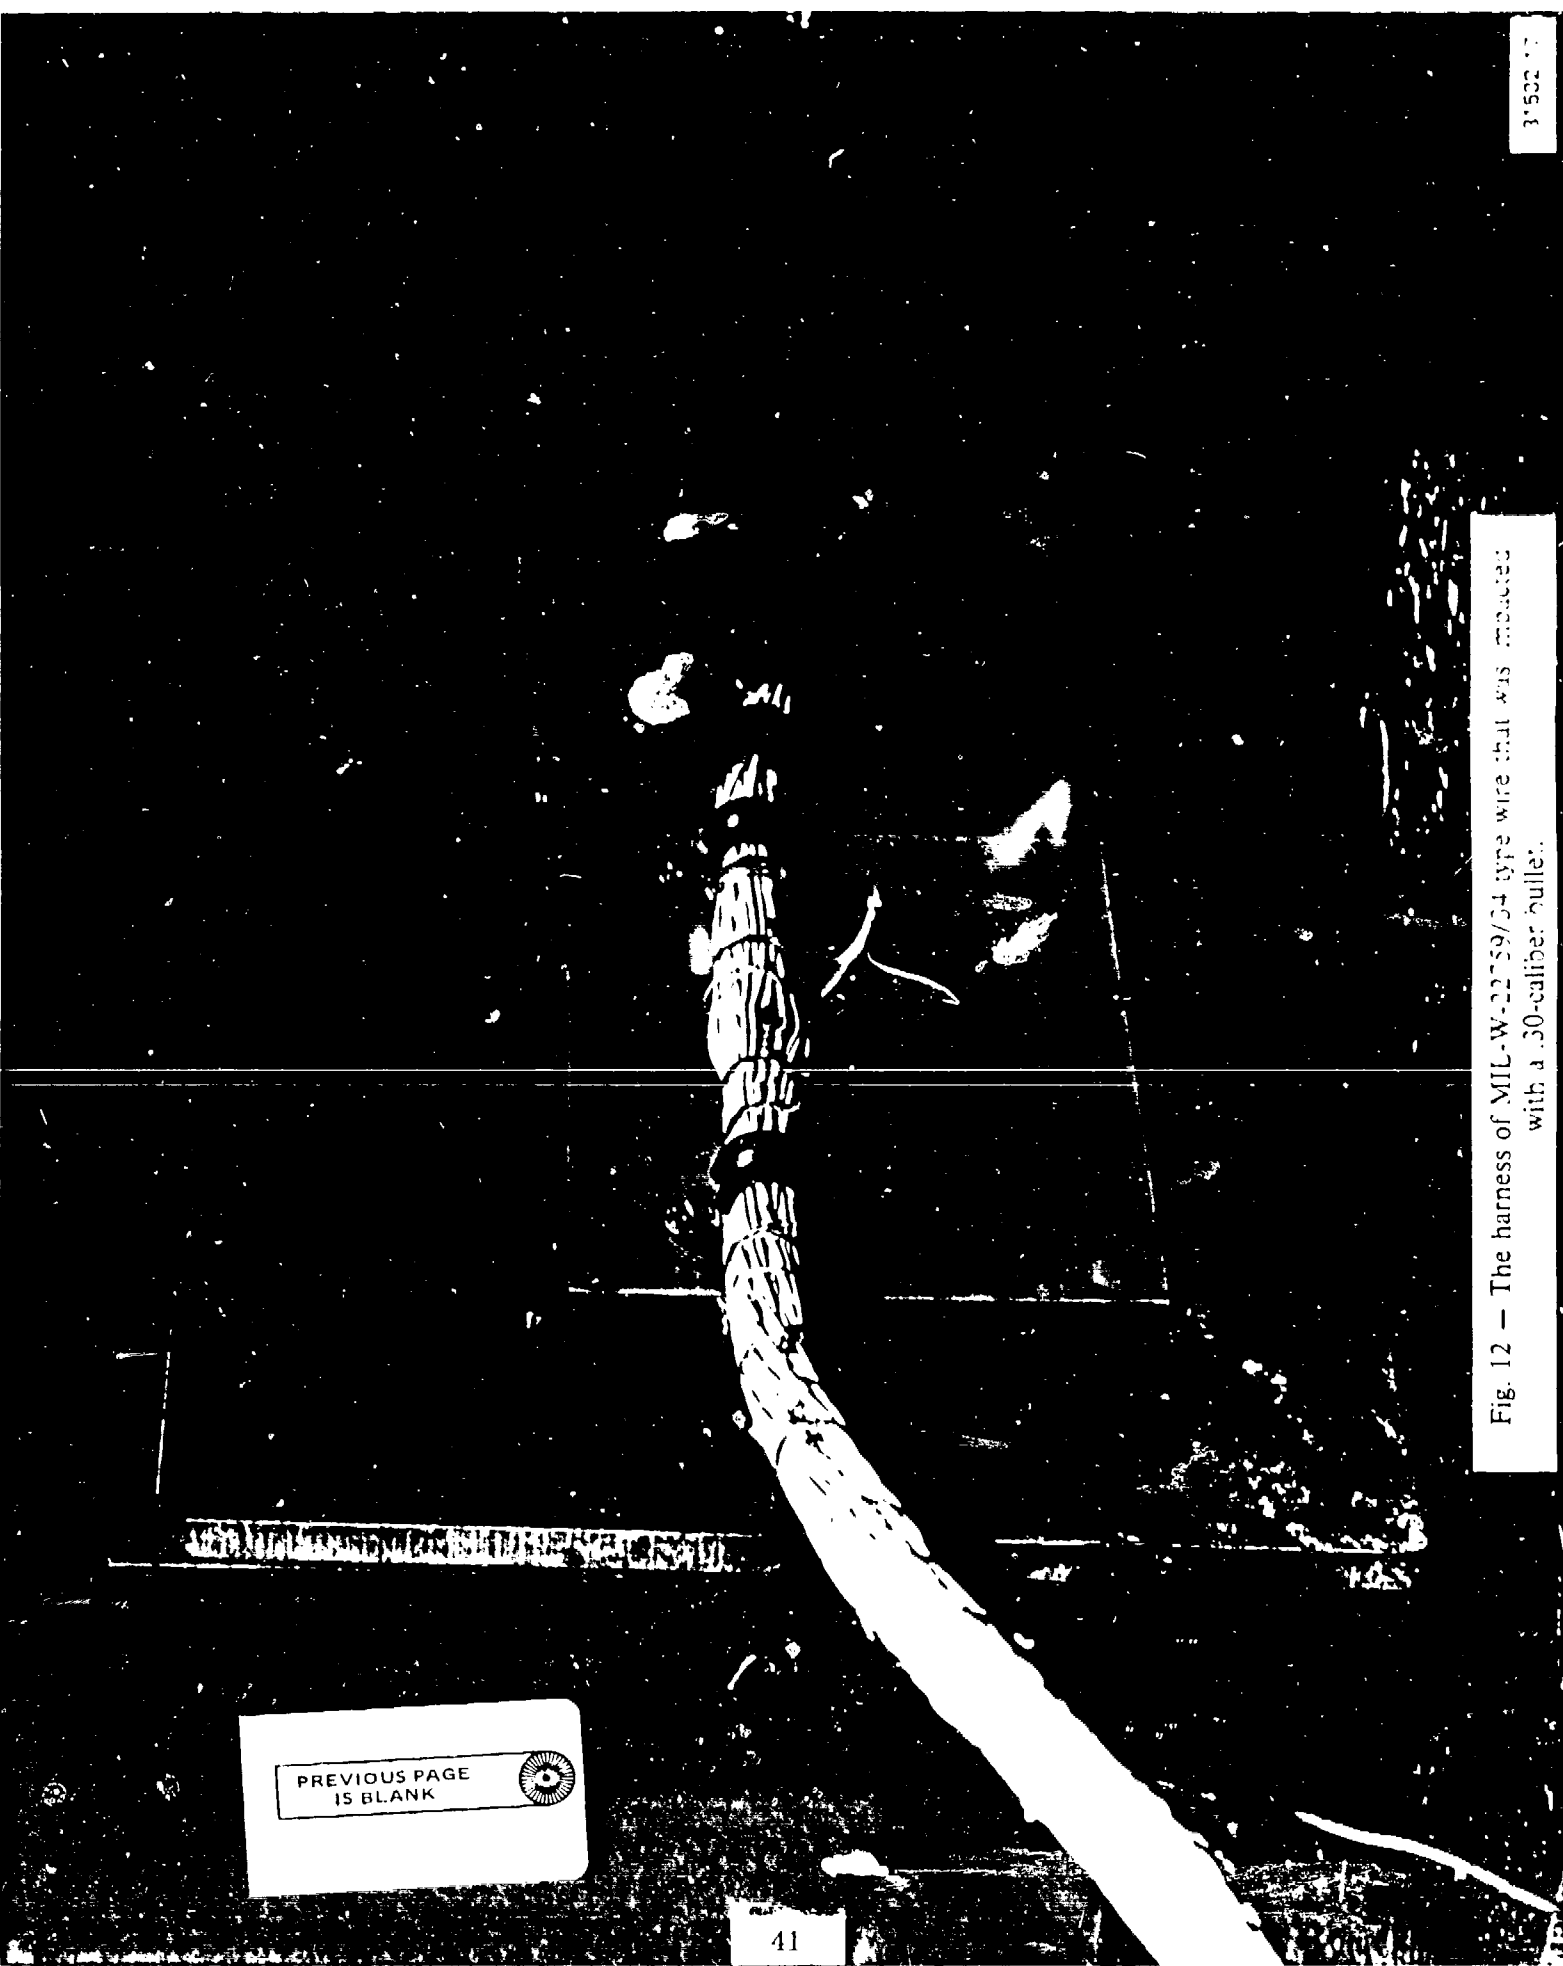
The projectile hit the midline of the harness. At the point of impact shown in Figure 12 it can be observed that at least one wire was severed, but no carbon formation can be seen and no circuit breakers were tripped.

Fig. 12 — The harness of MIL-W-2259/34 type wire that was impacted with a .30-caliber bullet.

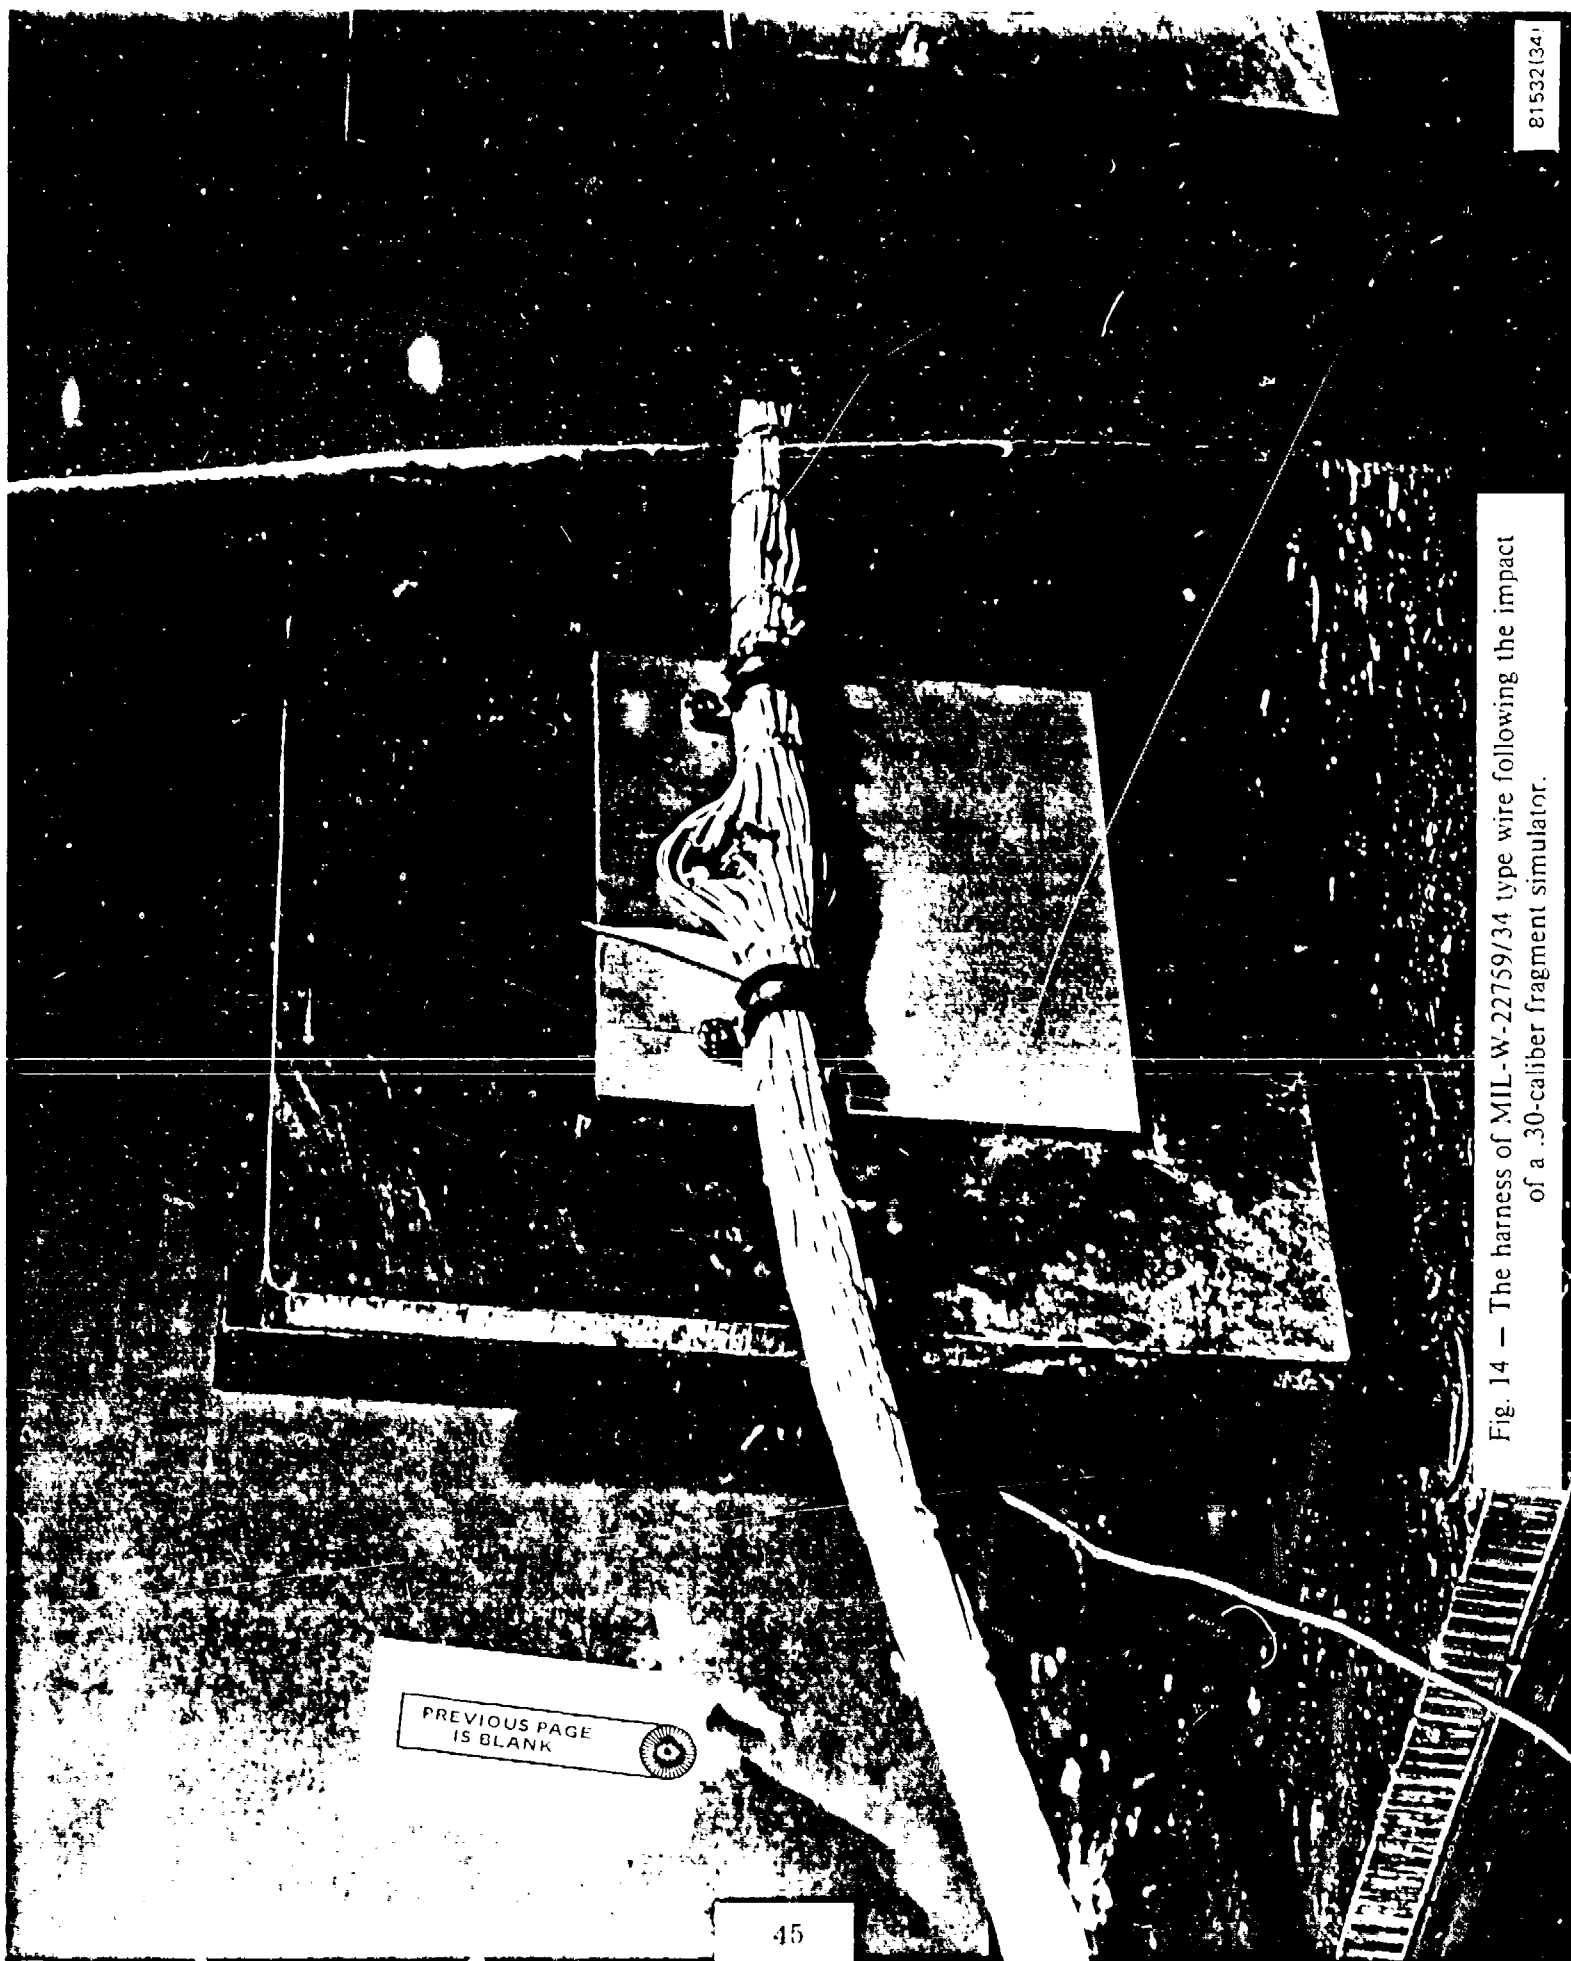
Figure 14 shows the harness with the damaged wires. Even though many of the wires in the harness were badly damaged by the impact there were no flames or ensuing fire to further damage the remaining wires.

Fig. 14 — The harness of MIL-W-22759/34 type wire following the impact of a .30-caliber fragment simulator.
